RAILWAY INVESTIGATION REPORT

R00M0044

MAIN-TRACK DERAILMENT

CANADIAN NATIONAL
FREIGHT TRAIN Q122-21-09
MILE 163.1, NAPADOGAN SUBDIVISION
BLUE BELL, NEW BRUNSWICK
09 DECEMBER 2000

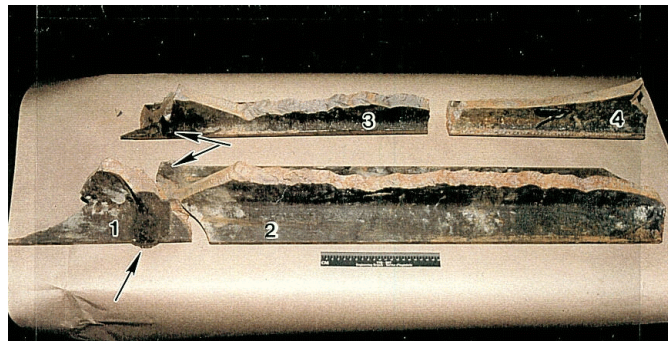
Photo 1. Four pieces of broken rail. Arrows denote location of thermite weld.

- The four rail pieces failed as a result of overstress. No pre-cracking was observed on any of the pieces received.
- The overstress failure initiated in the thermite weld, on top of the base of the rail, field side, indicating that the rail was in tension at that location, and consistent with a force applied from the gauge side of the rail.
- Material and hardness results observed on the rail sections were typical of rail material.
- Vertical wear was 9.5 mm, and combined vertical and lateral wear was 19 mm. Both measurements were within allowable wear limits.
- There was light micro-shrinkage porosity in the thermite weld area.
- Microstructure grain size was relatively large within the thermite weld area as compared to the fine grain size in the base metal. The larger grain size of the thermite weld area may facilitate crack propagation once a crack is initiated.

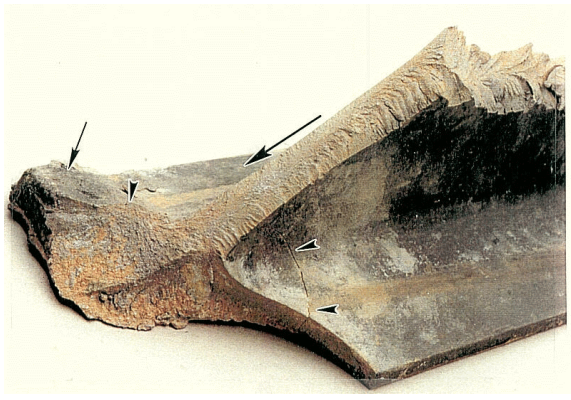
Photo 2. Top view showing thermite weld area, fracture initiation site, chevron markings, and other fracture locations

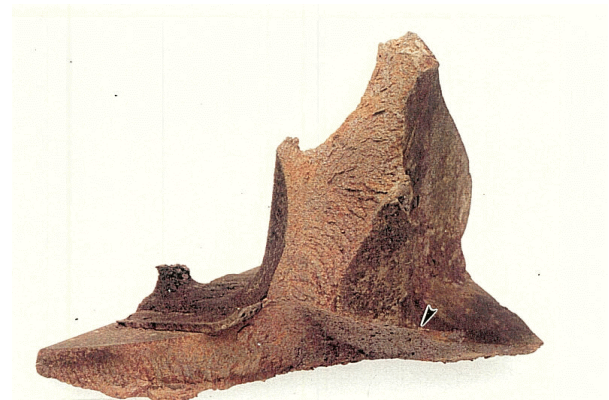
Photo 3. Mating piece of rail showing thermite weld area and fracture initiation location

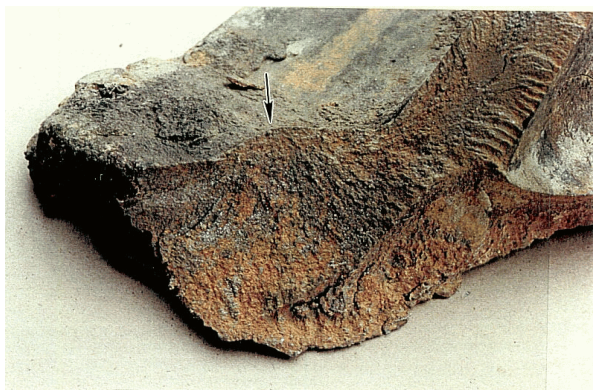
Photo 4. Close-up of fracture initiation location in thermite weld

Lateral wear on the high rail was indicative of in-train curving forces exerted upon the rail, creating tensile stresses on the field side of the rail. As the temperature was very low, contraction caused high tensile stresses³ in the rail. The combination of tensile stresses generated by in-train curving forces, stresses introduced through surfacing and the low temperature was sufficient to initiate a fracture in the field side of a thermite weld, where large grain size steel microstructure and micro-shrinkage porosity were present.

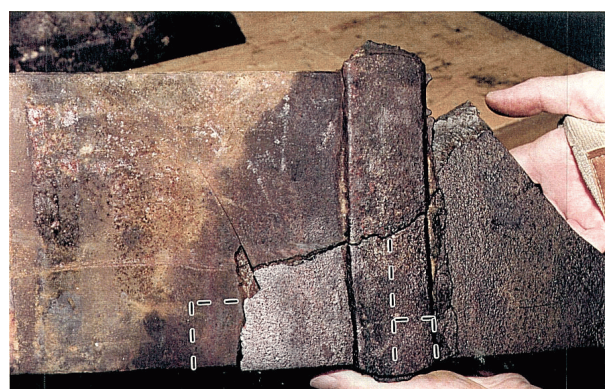
Photo 5. Bottom view of rail base showing location of fracture and thermite weld
